N-2500 Repair Kit

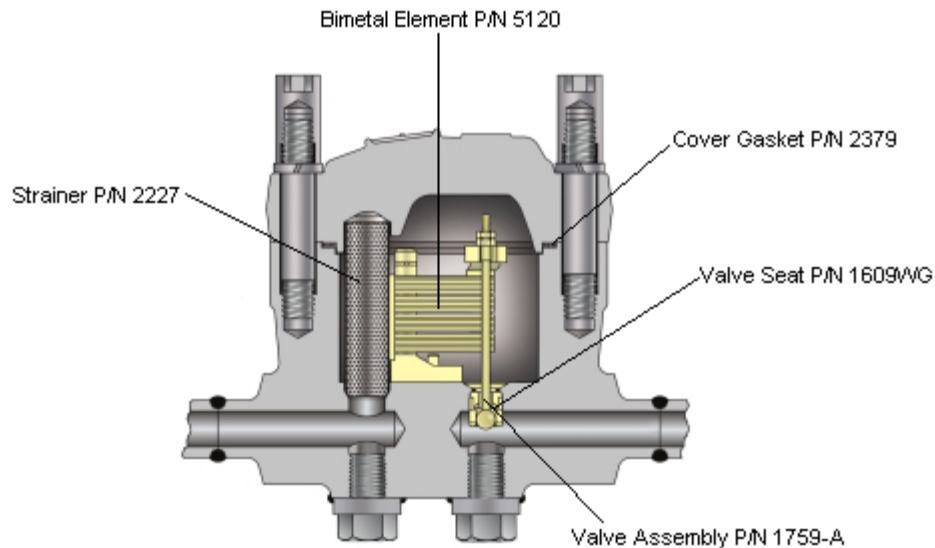
- (1) Bimetal Element Part Number 5120
- (1) Cover Gasket Part Number 2379
- (1) Strainer Part Number 2227
- (1) Valve Assembly Part Number 1759-A
- (1) Valve Seat Part Number 1609WG

*Note, N-2500 plugs are welded, there are no plug gaskets.

*Tools required for repair:
Stem Key Part Number L99002
Seat Locating Tool Part Number L99046/1
