VELAN

STEP BY STEP SPF REPAIR GUIDE

Step-by-step SPF Repair Guide

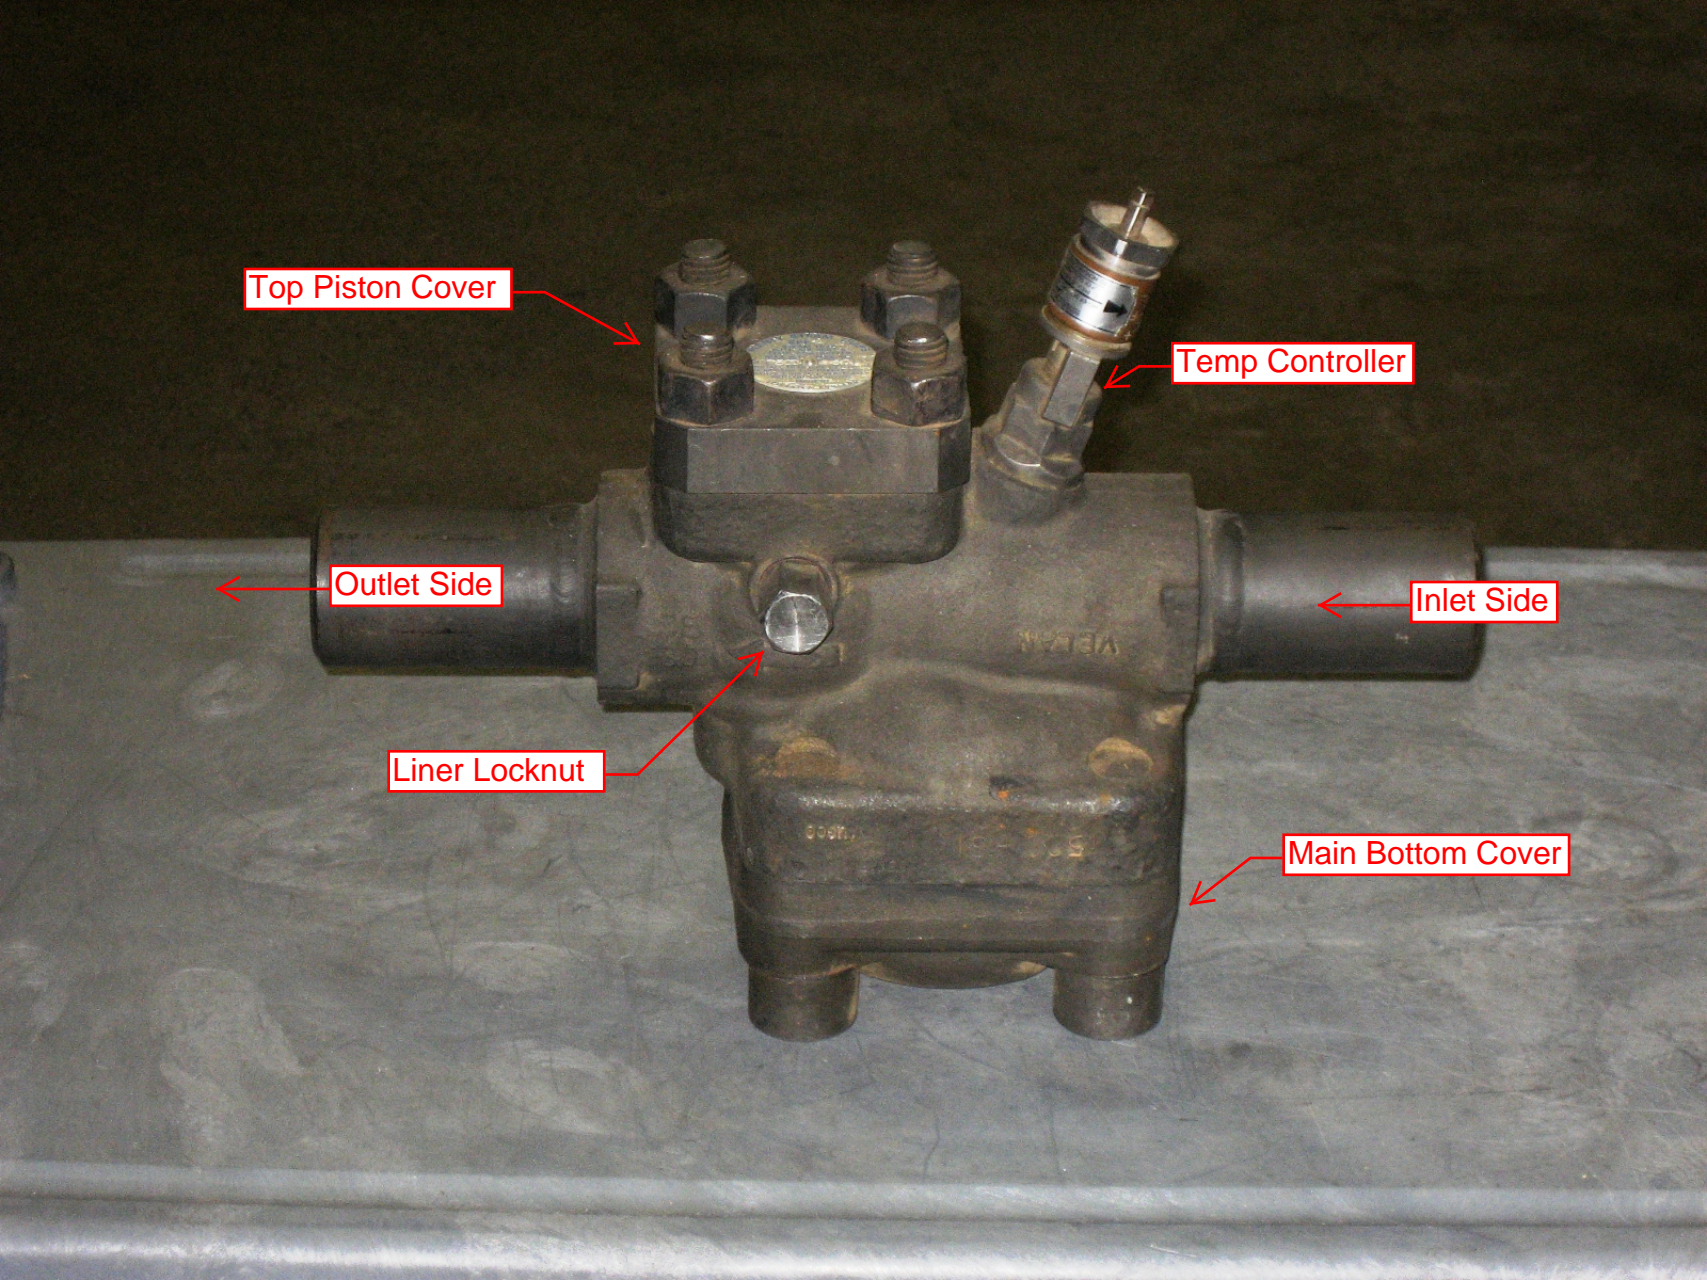
NOTE: Use a wire brush to clean any residual gasket material, ensuring the body and cover gasket seating faces are clean and undamaged.

1. Reset the **Temperature Controller** to the centered neutral position

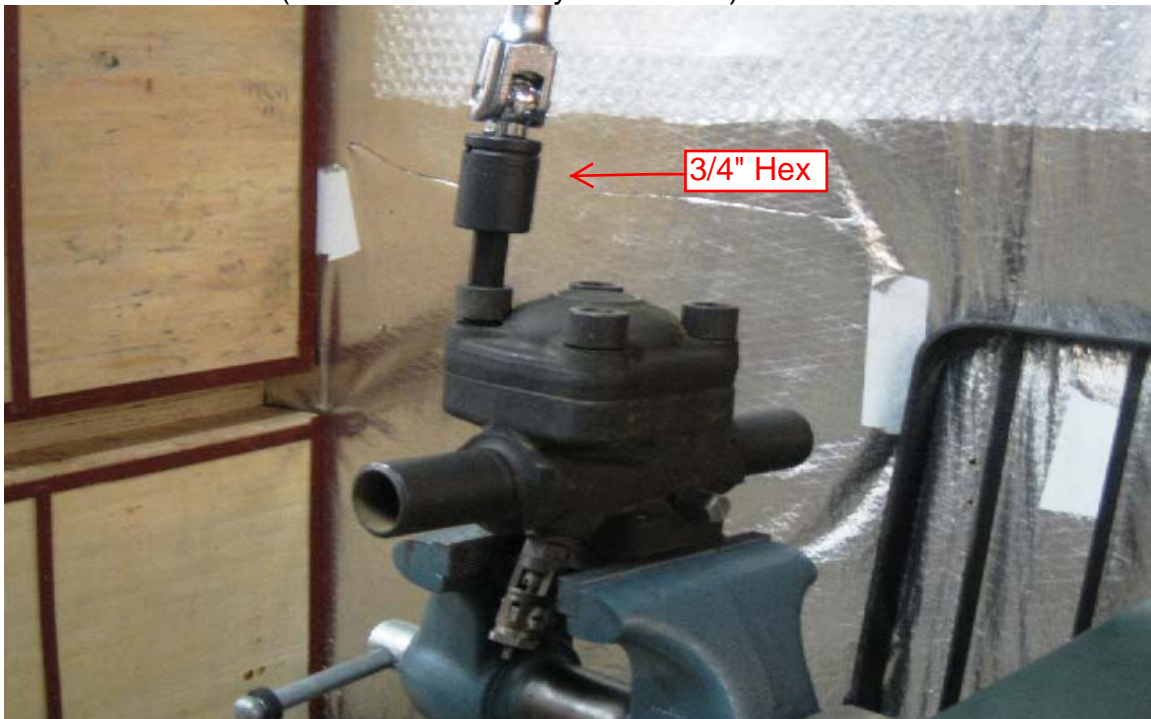
3. Remove the **Main Bottom Cover Gasket** and discard.

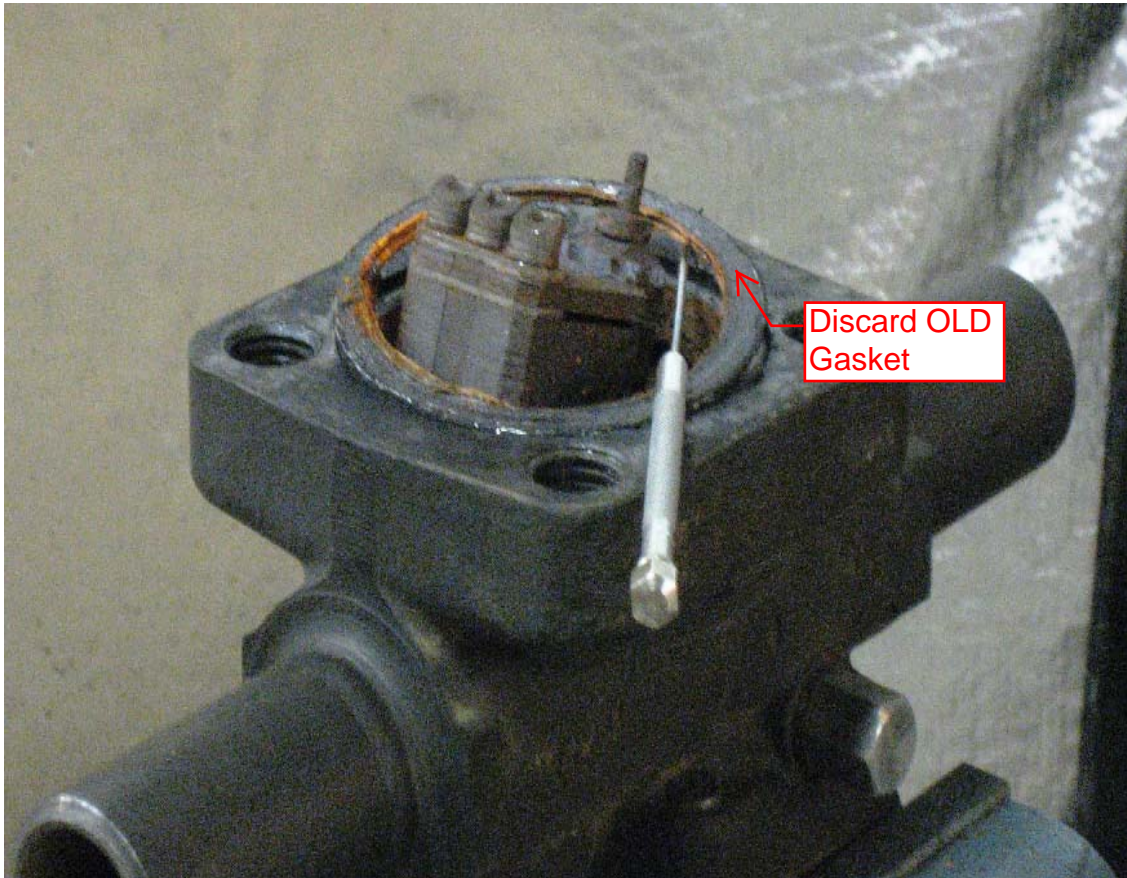
4. Remove the allen head **Cage Unit Bolts** and save for re-assembly

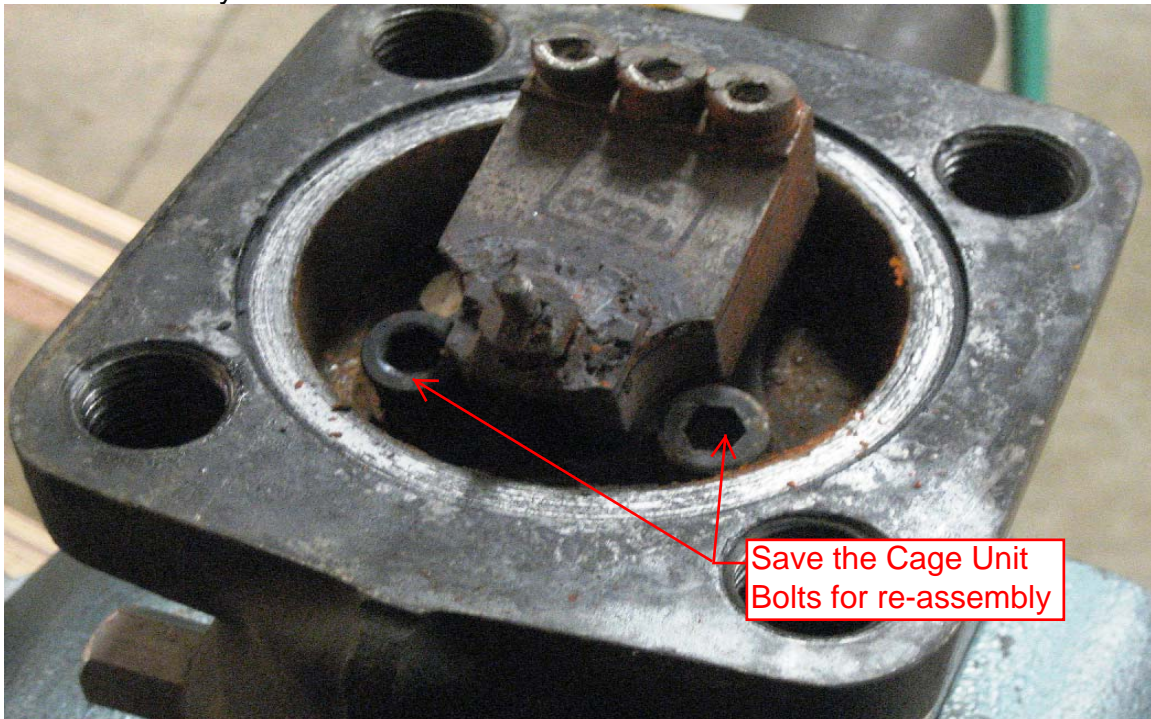
5. Remove the **Cage Unit** inspecting seating faces for wear or damage

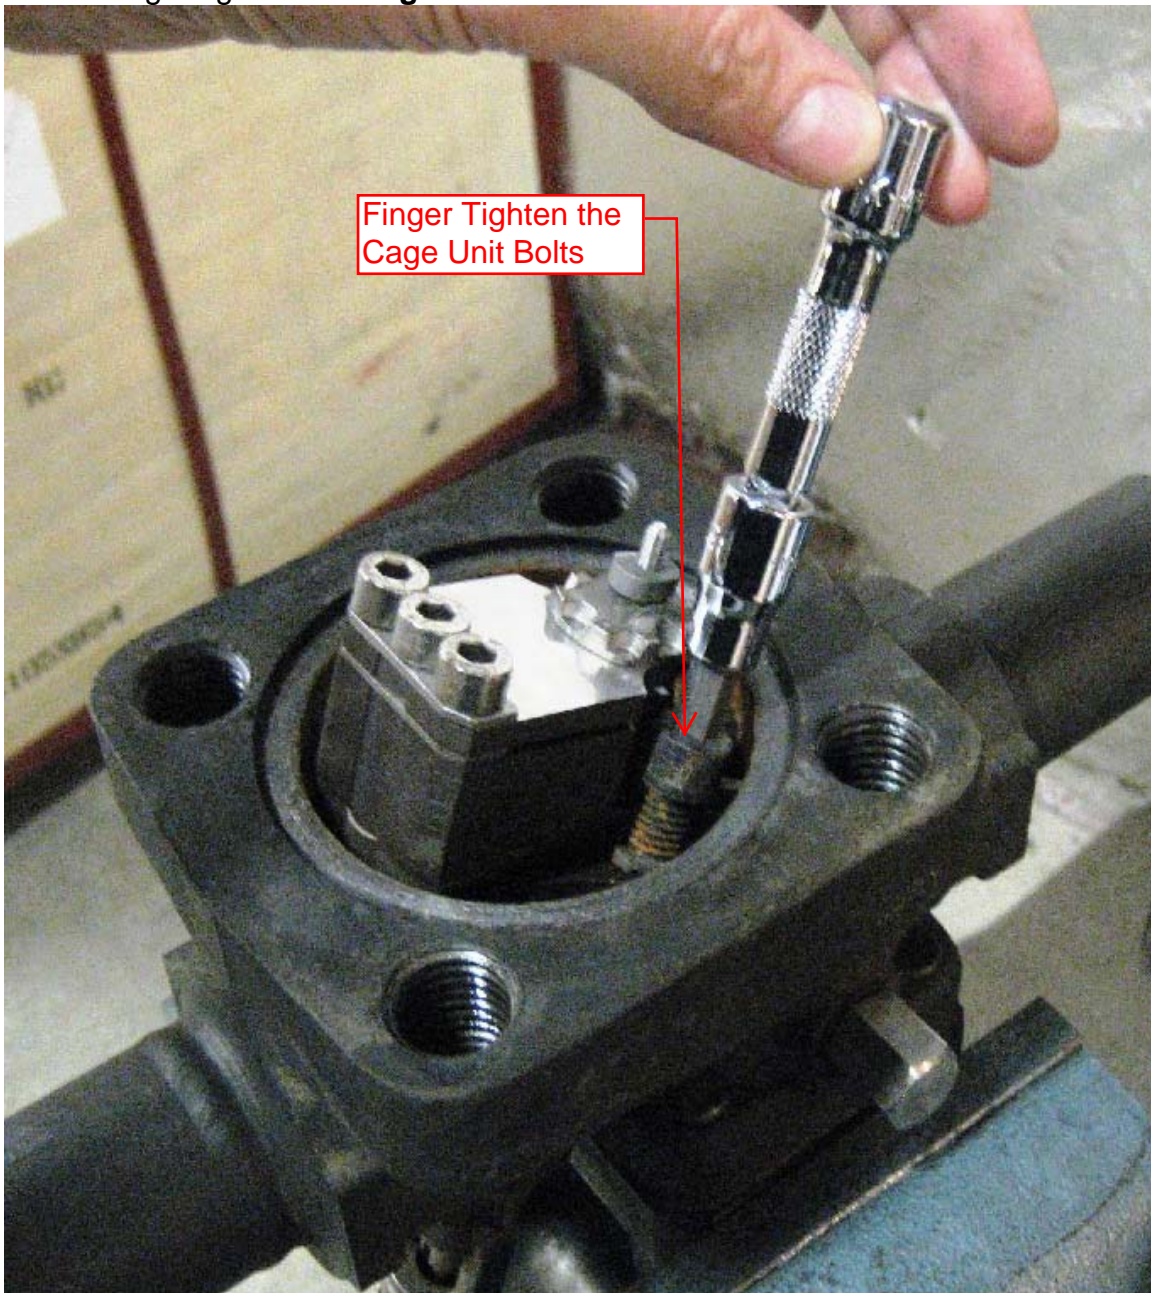
10. Carefully tighten the **Cage Unit Bolts** evenly (a $\frac{1}{2}$ turn alternating back and forth until you reach the desired bolting torque of 35 ft-Lb)
11. Insert a **NEW Main Bottom Cover Gasket**, replace the **Main Bottom Cover** and finger tighten the **Main Cover Bolts**. Utilizing ANTI-SEIZE or some comparable product on the bolt threads will make future trap repairs quicker and easier. **DO NOT TIGHTEN MAIN COVER BOLTS YET.**

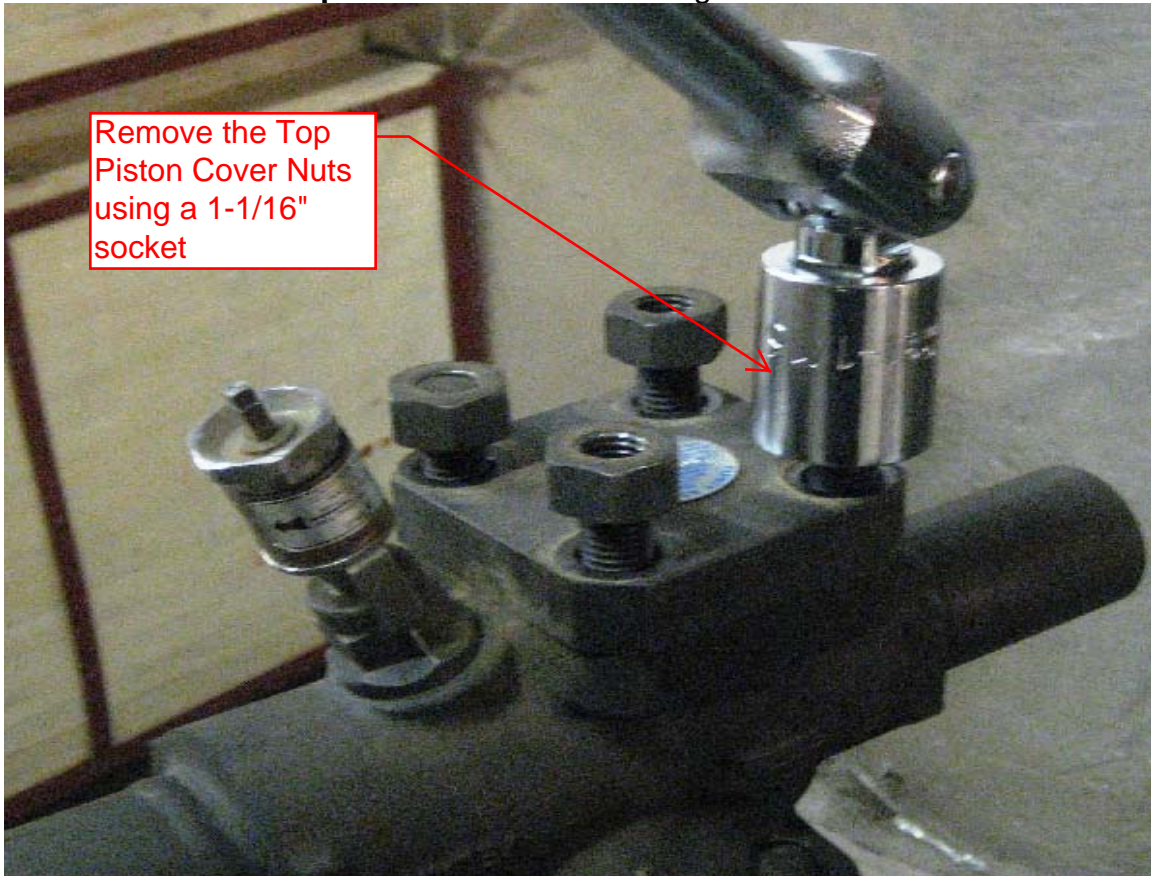
12. Remove the **Top Piston Cover Nuts** using a 1-1/16" X 3/4" drive socket

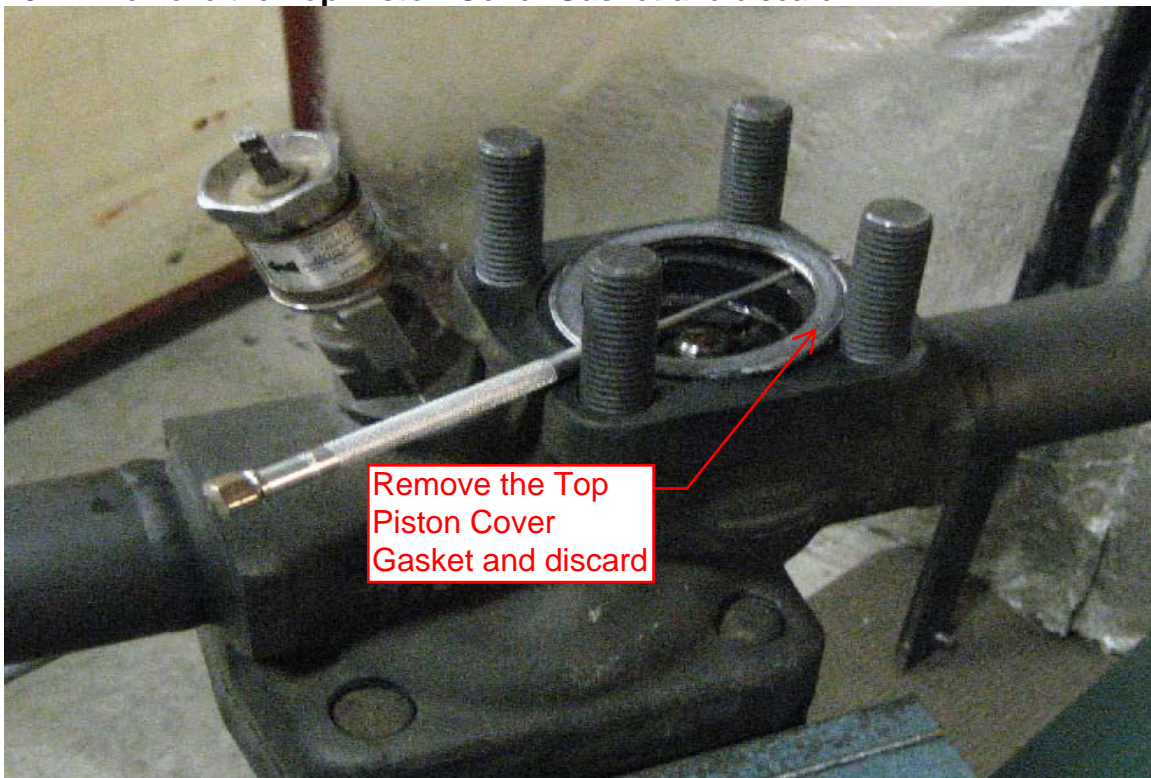
13. Remove the **Top Piston Cover Gasket** and discard

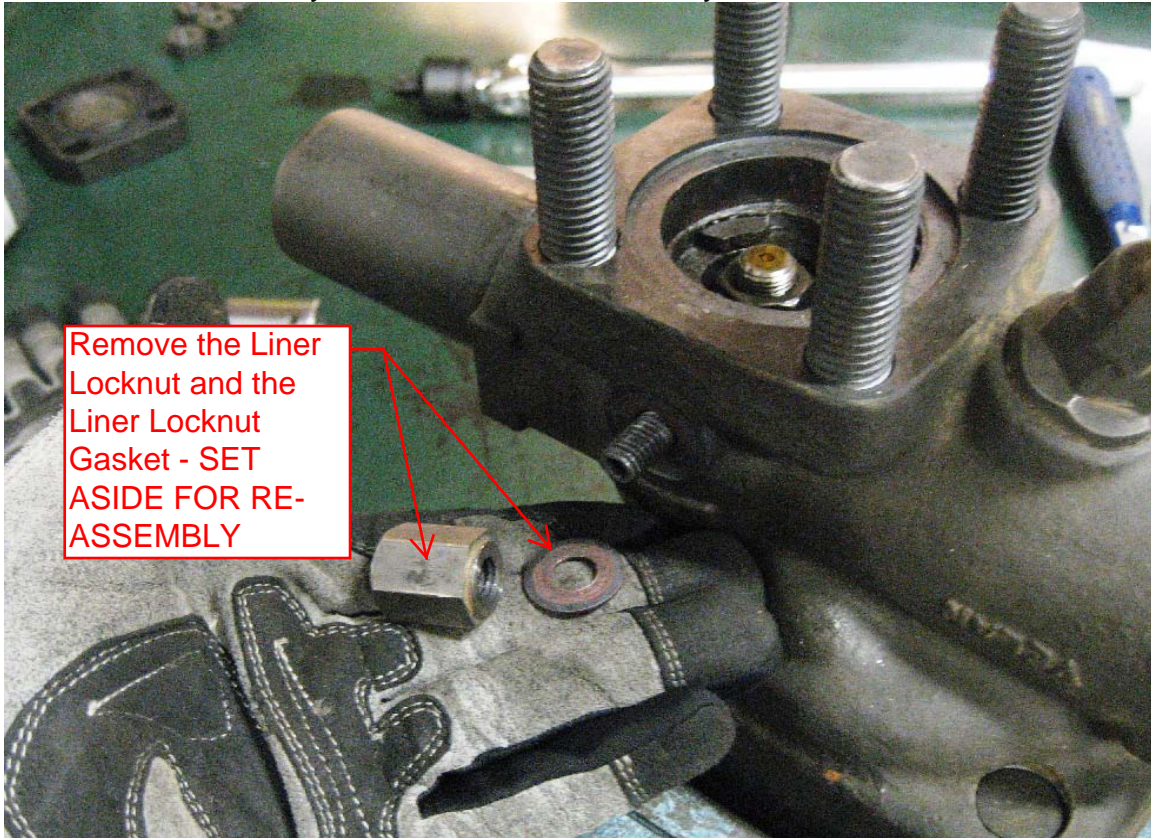
14. Remove the **Liner Locknut** and the **Liner Locknut Gasket** located on the side of the body – set aside for re-assembly.

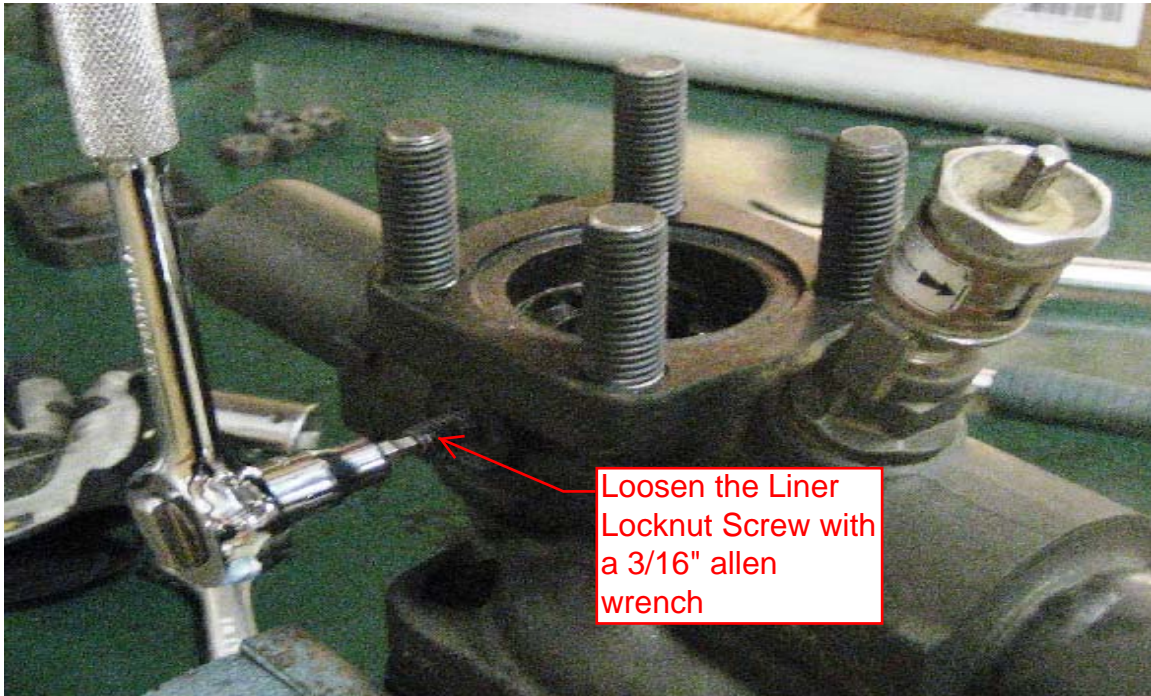
15. Loosen the **Liner Locknut Screw** with an allen wrench to allow rotation of the **Liner Valve**.

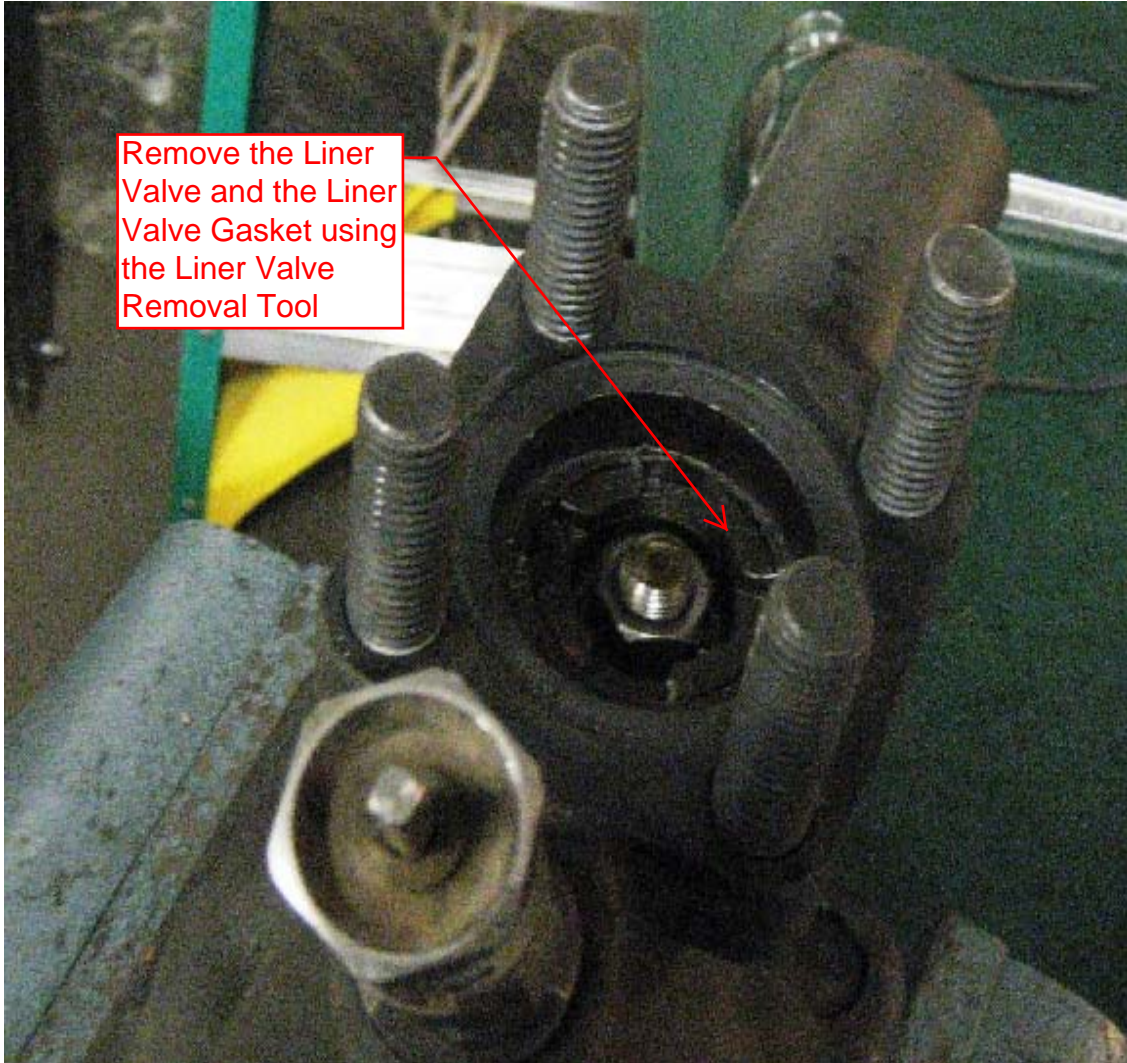
16. Use the **Liner Valve Removal Tool** to remove the **Liner Valve** and **Liner Valve Gasket**. Carefully inspect the seating faces for wear or damage. Discard the **OLD Liner Valve Gasket**.

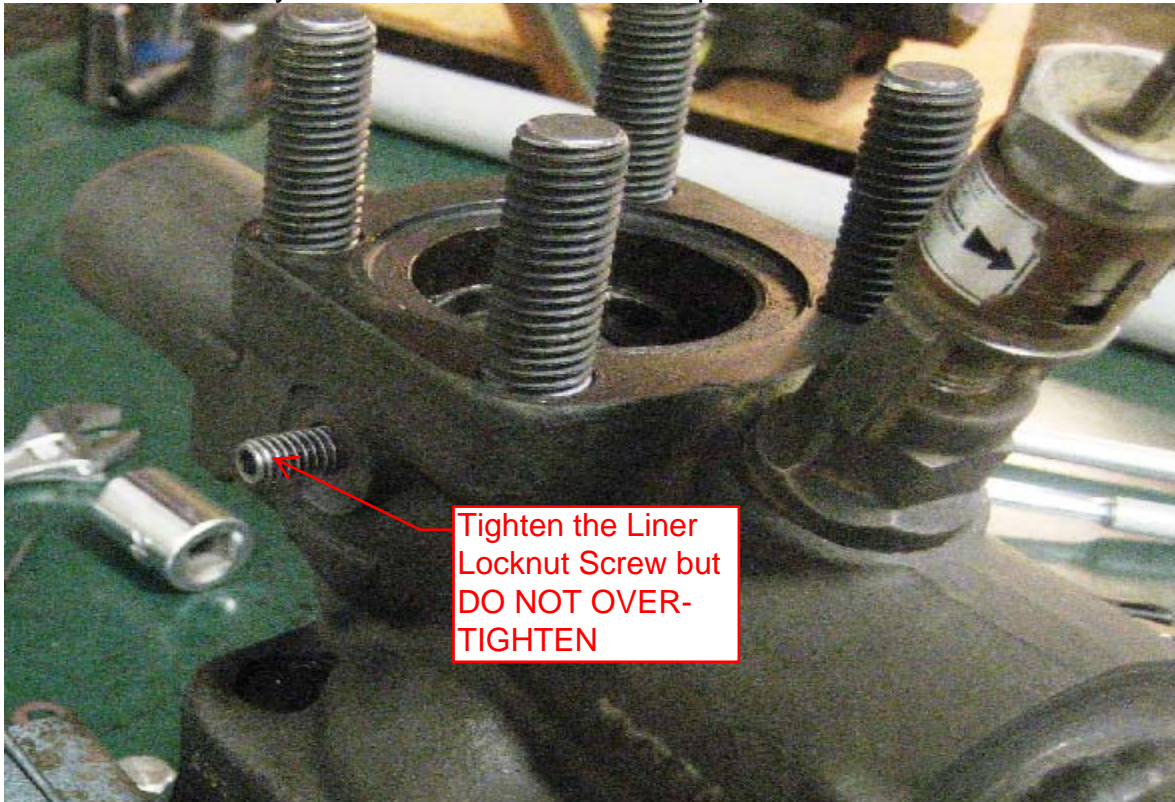
17. Insert the **NEW Liner Valve Gasket** making sure the area is clean of dirt and debris
18. Insert the **NEW Liner Valve** and ensure the liner valve is effectively tightened to seal the gasket.

19. Tighten the **Liner Locknut Screw** to secure the **Liner Valve** but DO NOT over-tighten. Over-tightening may cause distortion in the liner bore, which will adversely affect free movement of the piston

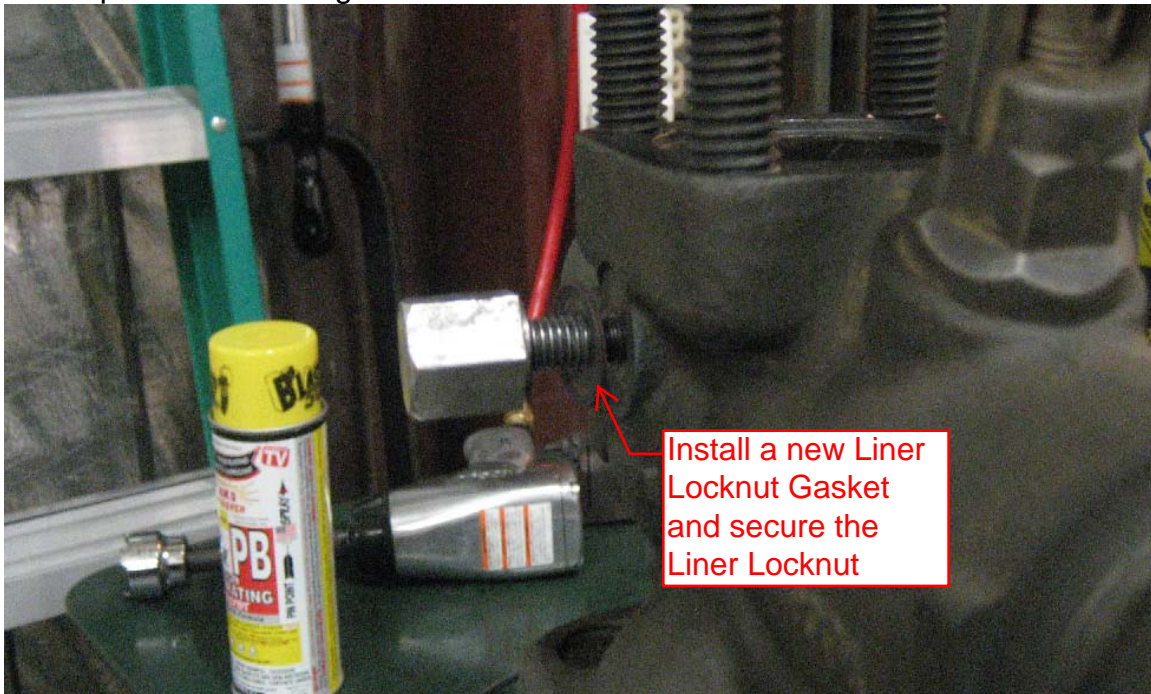
20. Install a **NEW Liner Locknut Gasket** and secure the **Liner Locknut** to prevent loosening of the **Liner Locknut Screw**.

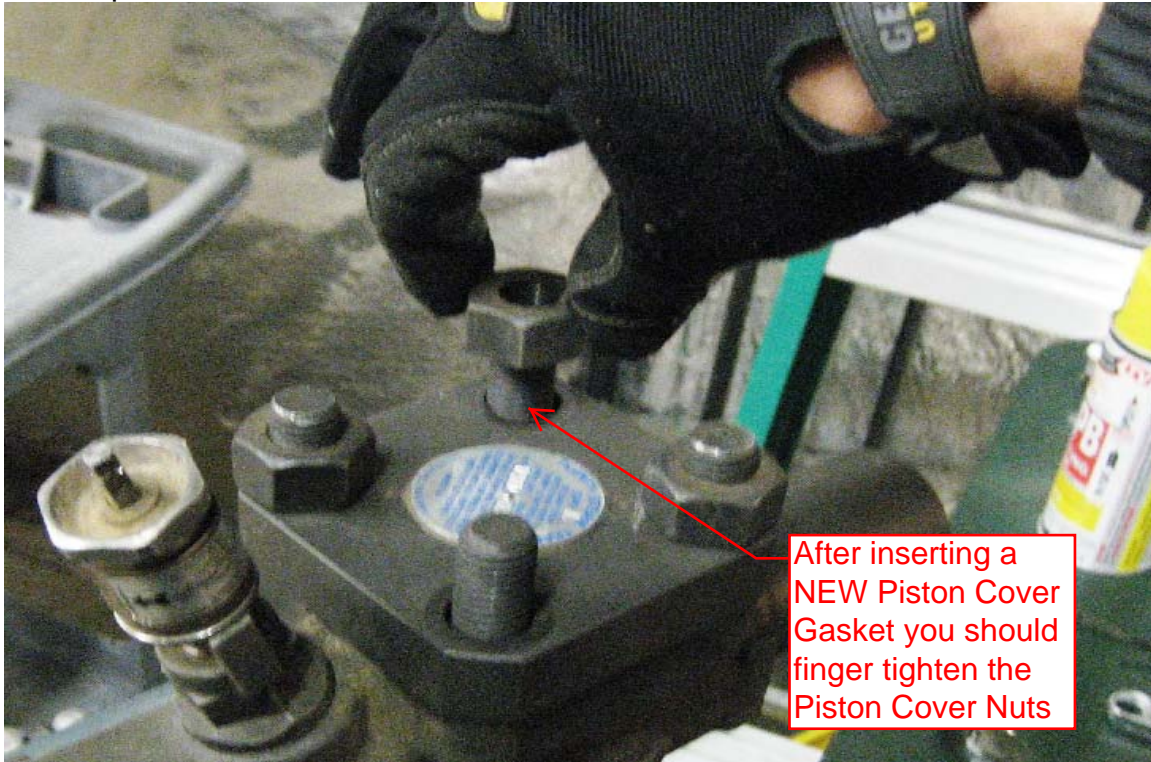
21. Insert a **NEW Piston Cover Gasket**, replace the **Top Piston Cover** and finger tighten the **Piston Cover Nuts**. Utilizing **ANTI-SEIZE** or some comparable product on the bolt threads will make future trap repairs quicker and easier.

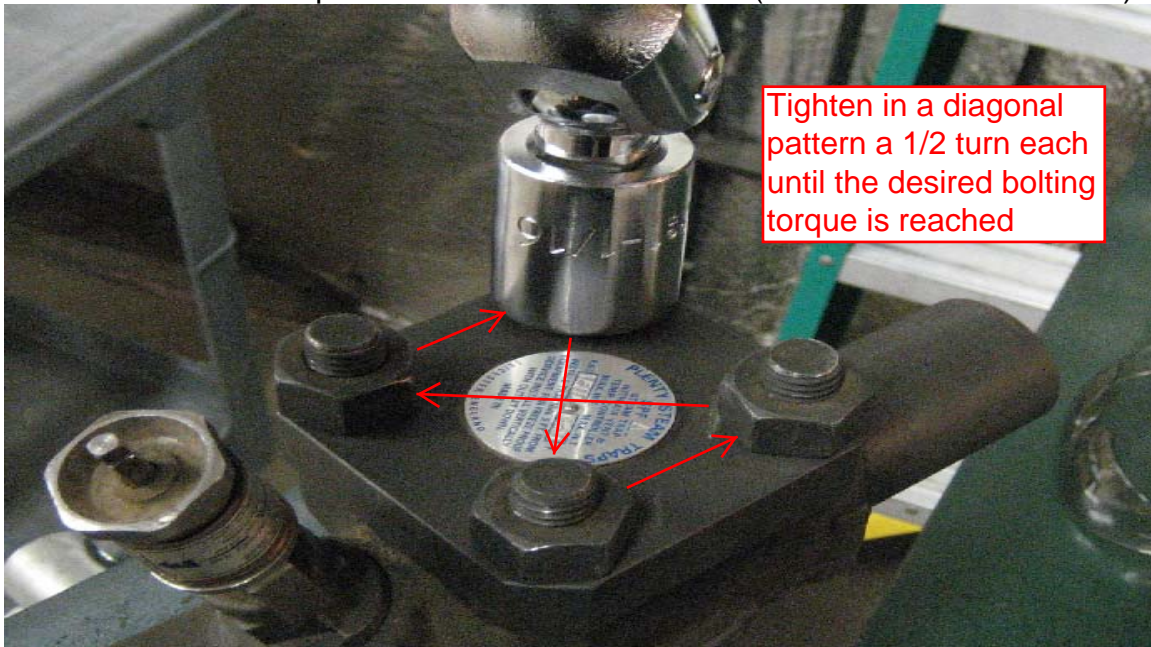
22. When you are certain ALL steps have been completed successfully, tighten the **Piston Cover Nuts** evenly in a diagonal pattern until you reach the desired torque of 60 ft-Lbs for the SPF0-3 (100 ft-Lbs for the SPF4-7)

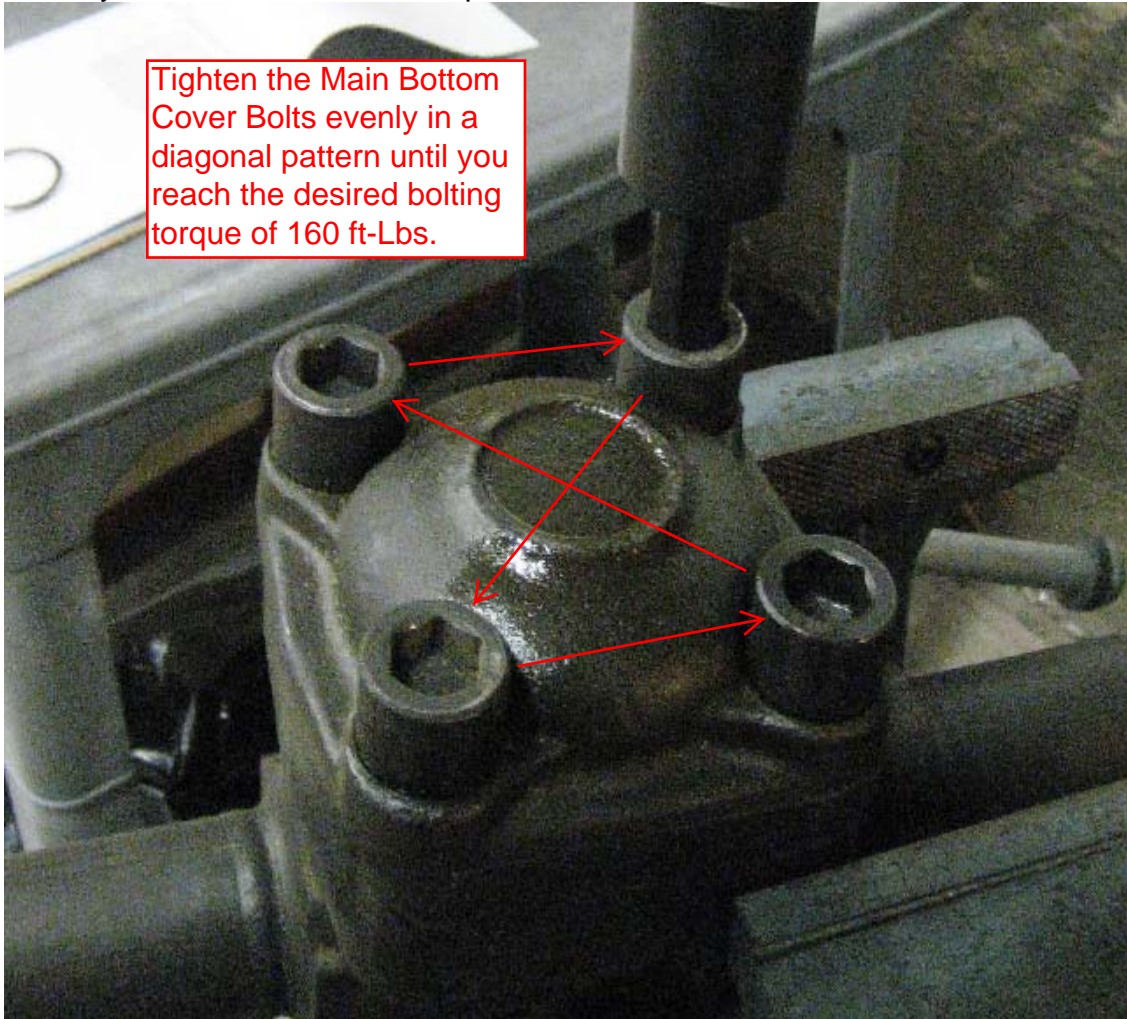
23. Tighten the **Main Bottom Cover Bolts** evenly in a diagonal pattern until you reach the desired torque of 160 ft-Lbs
