MFT5-15 Repair Kit

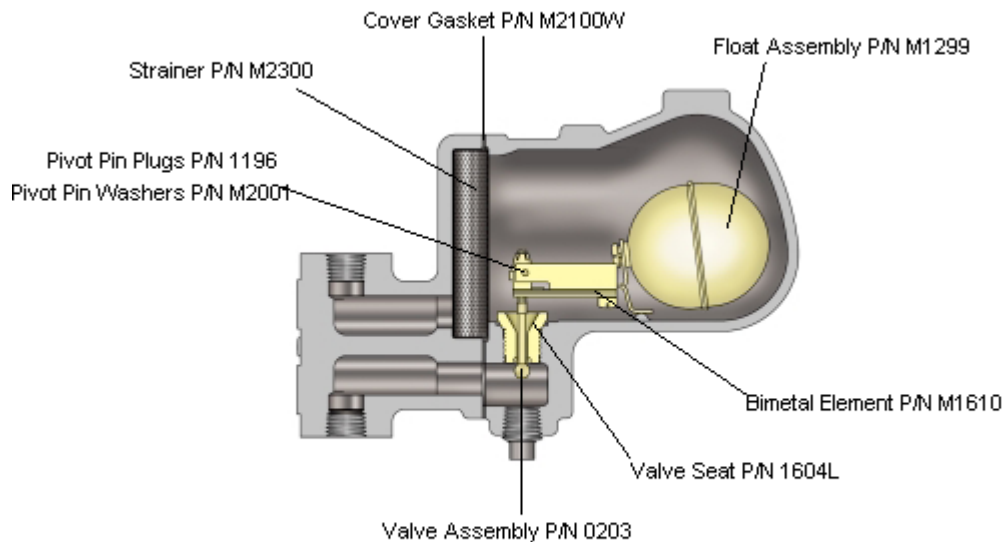
- (1) Bimetal Element Part Number M1610
- (1) Float Assembly Part Number M1299
- (1) Valve Assembly Part Number 0203
- (1) Valve Seat Part Number 1604L
- (1) Cover Gasket Part Number M2100-W
- (1) Strainer Part Number M2300
- * (2) Pivot Pin Plug Part Number 1196
- * (2) Pivot Plug Washer Part Number 2001

*Tools required for repair:
Stem Key Part Number L99001
