N-1500 Repair Kit

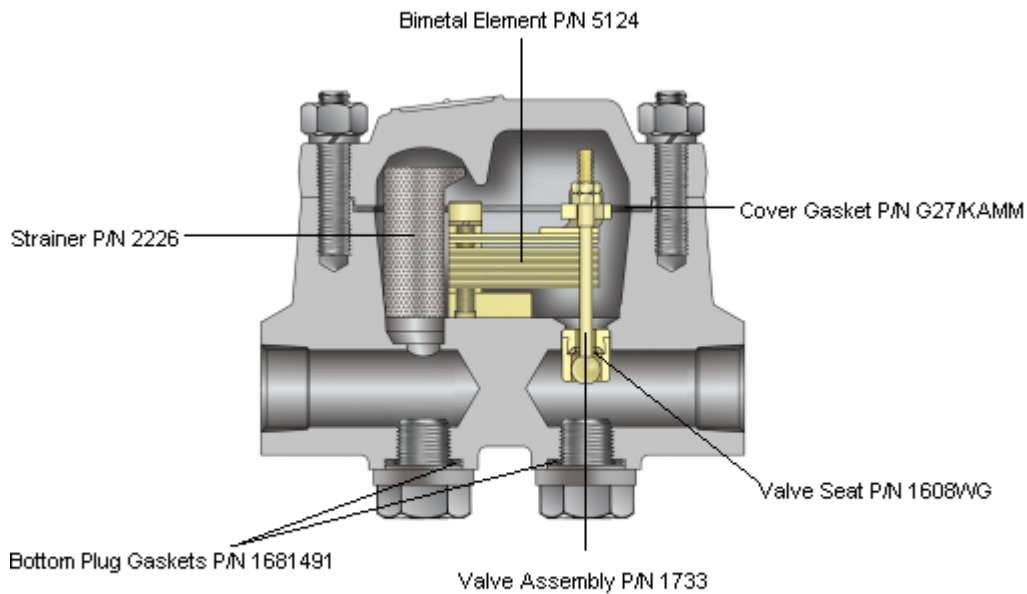
- (1) Bimetal Element Part Number 5124
- (1) Cover Gasket Part Number G27/KAMM
- (1) Strainer Part Number 2226
- (1) Valve Assembly Part Number 1733
- (1) Valve Seat Part Number 1608-WG
- (2) Bottom Plug Gaskets Part Number 1681491
