N-675 Repair Kit

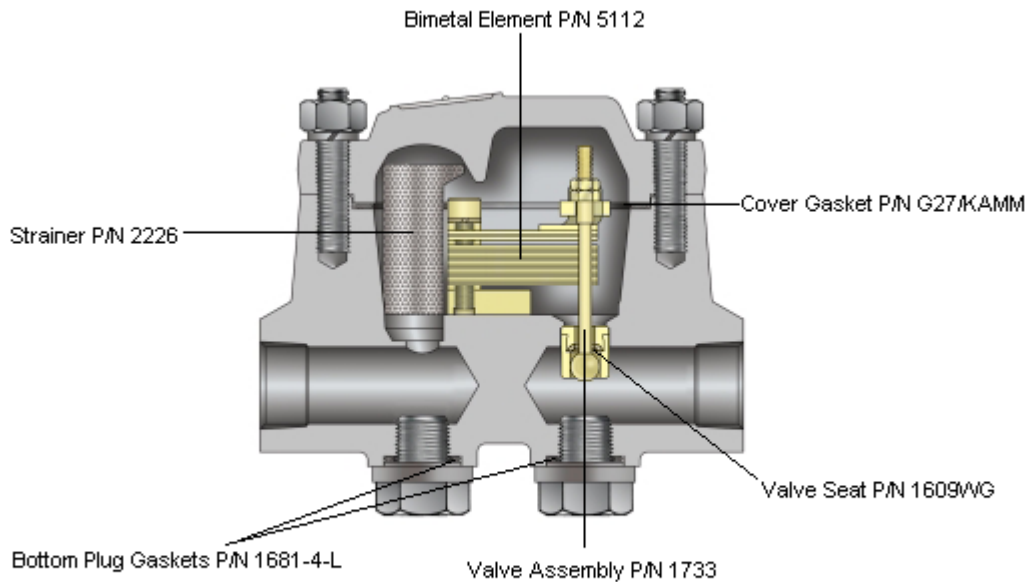
- (1) Bimetal Element Part Number 5112
- (1) Cover Gasket Part Number G27/KAMM
- (1) Strainer Part Number 2226
- (1) Valve Assembly Part Number 1733
- (1) Valve Seat Part Number 1609WG
- (2) Bottom Plug Gaskets P/N 1681-4-L
